## **Flexural behavior of reinforced masonry panels**

Juliana T. Oliveira, Joaquim O. Barros

Report 02-DEC/E-10

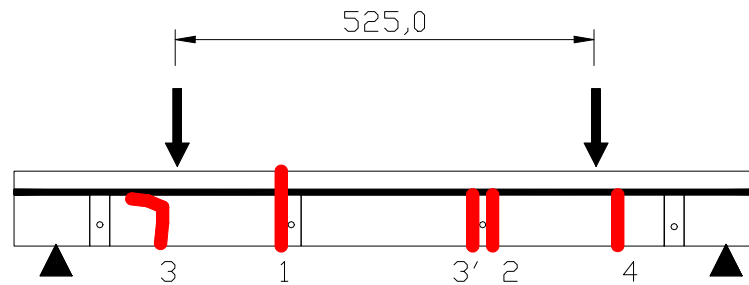
In spite of being part of the same series this panel has failed by bending, while the previous one has failed by shear. At a load of 25 kN fissures 1 and 2 were formed at concrete joint/brick interface. At a load of 48 kN fissure 3 appeared under the left line load and fissure 3' in the concrete joint/brick interface. Fissure 4 occurred at a load of

68 kN. The crack opening process of fissures 1 and 3' has increased significantly at a load of about 82 kN. After the deflection corresponding to maximum load the panel entered in structural softening and at a load of about 70kN fissure 1 has widen significantly and the longitudinal reinforcement has ruptured in this section, see Figure 82. Figure 81 reveals that the panel deformability was quasi-symmetrical.

Figure 80 - Crack pattern in FLC-2B.

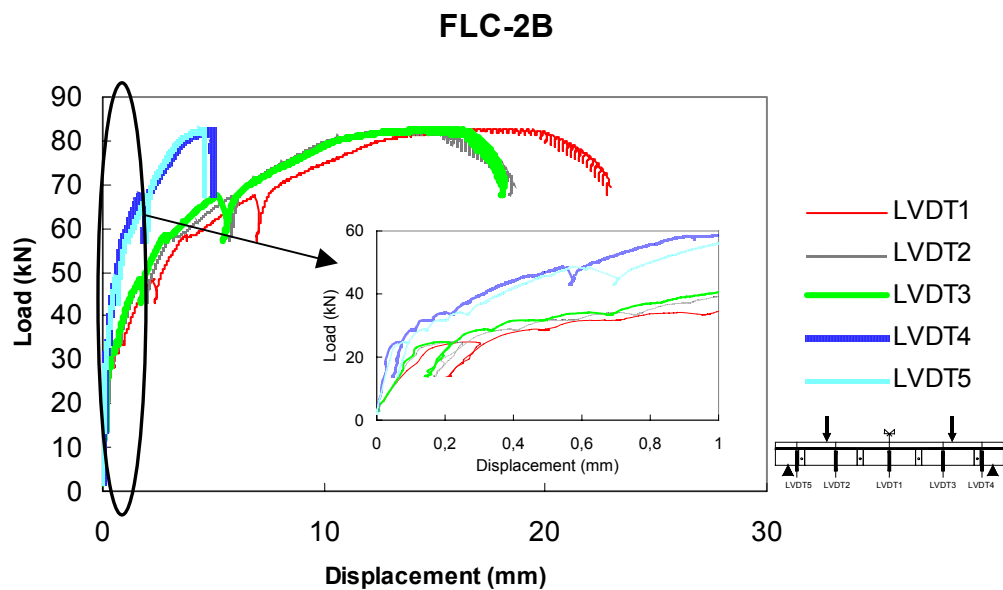
Figure 81 - Force-displacements relationship for all LVDTs.

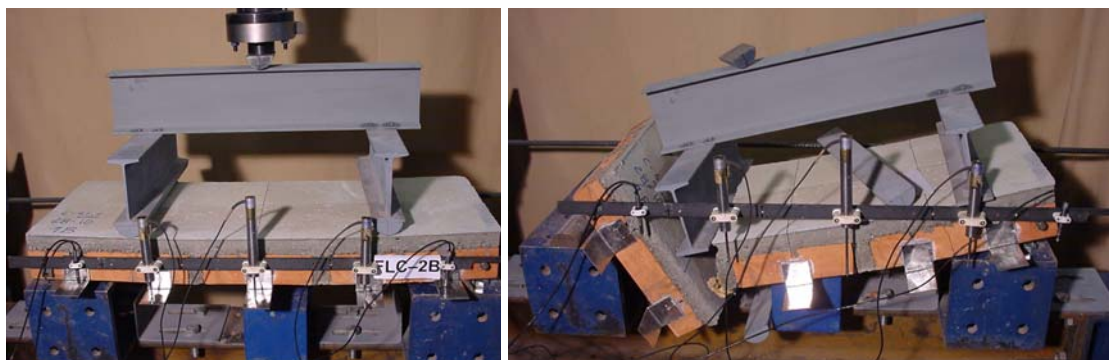
Figure 82 – Aspect of the panel FLC-2B after have been tested.

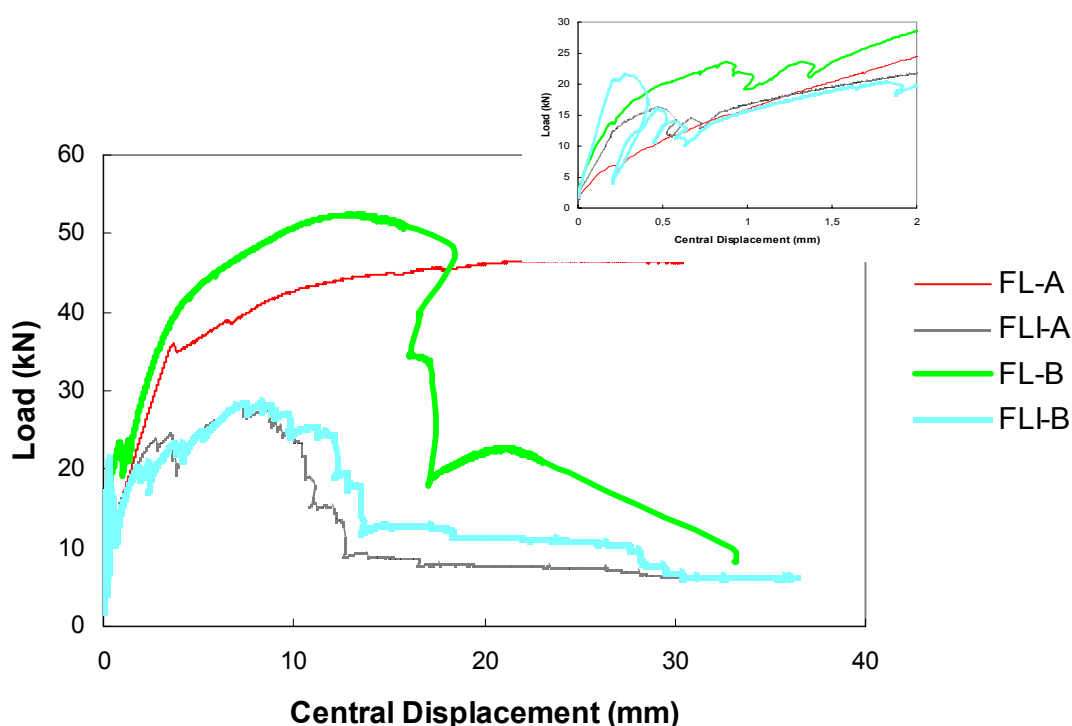
Figure 83 includes the relationship between the average force and the mid span deflection of series FLA, FLI-A, FLB and FLI-B. As series FLB had three concrete ribs (the joints) in the longitudinal direction, while FLA had only two, FLB showed higher initial stiffness. Besides higher stiffness, series FLB had also larger load bearing capacity than series FLA. The cross sectional area of the longitudinal reinforcement of series FLB was lower than the one of series FLA ( $A_s = 84.8 \text{ mm}^2$  in FLB and  $A_s = 100.5 \text{ mm}^2$  in series FLA), but the tensile yield stress and strength of the bars reinforcing series FLB ( $\phi 6$ ) were larger than the values obtained on the specimen's bars reinforcing series FLA ( $\phi 8$ ), see Annex 1.

Comparing the deformability response of the series up to a deflection of about 1 mm (see inset of Figure 83), it is visible that panels FL- entered firstly in non-linear behavior than series FLI-. This was due to the fact that in series FLI- the loss of linearity was due to cracking of the bottom concrete layer, while in series FL the cracking process has always mobilized the brick-concrete joint interface, which is a poor link in the panel system. Therefore, the higher initial stiffness of series FLI- was due to the tensile resistance provided by the concrete layer. After this layer have been cracked, the stiffness decreased significantly and crack propagation was followed by rupture of wires of the mesh. Due to wire mesh rupture, series FLI- showed lower ductility than series FL-.

Figure 83 – Relationship between the average force of the mid span deflection of series FL- and FLI-.

As it was expected, FLI-A and FLI-B series had similar maximum load bearing capacity and deformability behavior, since the amount and position of the tensile reinforcement were equal in both series. However, the force corresponding to crack

initiation was larger in series FLI-B, as this panel had three concrete ribs while series FLI-A had only two.

Series with the concrete layer turned upward (FLA and FLB) had higher maximum load than their counterpart's series with the concrete layer turned downward (FLI-A and FLI-B). This was due to the high tensile longitudinal reinforcement ratio and internal arm of series FLA and FLB (in series FLI the wire mesh was positioned at brick-concrete layer interface). The tension stiffening effect might have also contributed for this distinct behavior (Barros 1995). Due to the amount and position of the tensile longitudinal reinforcement, the tension stiffening effect in series FLI might have been marginal, while in series FLA and FLB it should be not neglected.

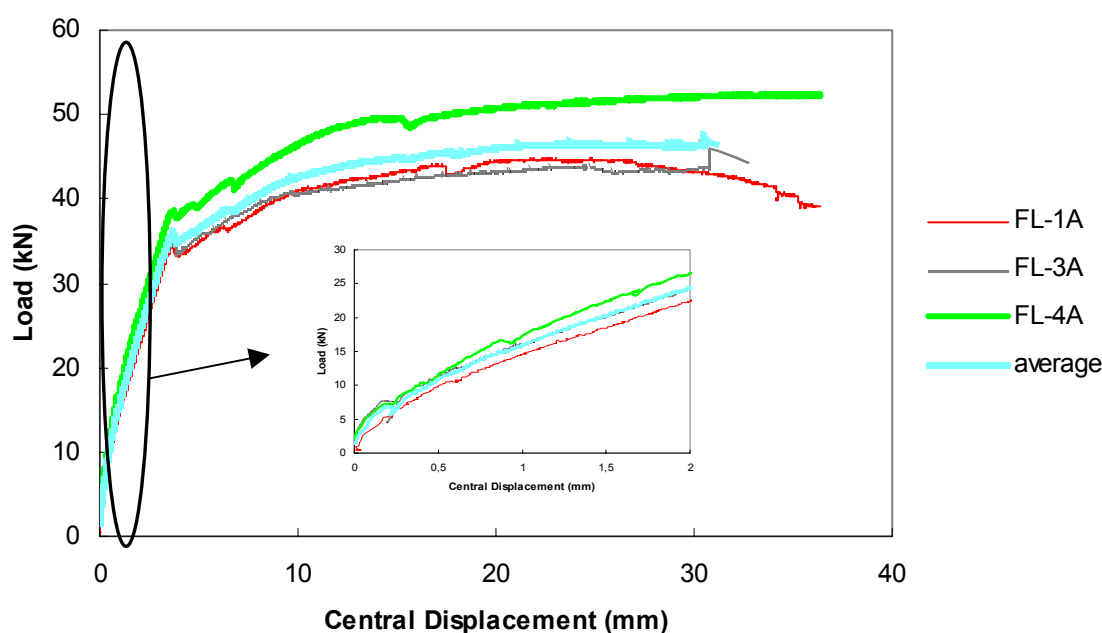
Figure 84 represents the force-mid span relationship of series FL-A. The panels of this series showed very similar deformability behavior, but panel FL-4A attained a higher ultimate load. After a very short linear branch corresponding to uncracked state, a quasi-linear force-deflection relationship was observed for the cracked state, up to the beginning of the yielding of the tensile reinforcement. Due to the formation of several cracks (four to six) stress redistribution was occurred, leading to a maximum load ( $F_{max}$ )

greater than the load corresponding to the steel yielding initiation ( $F_{sy}$ ). The hardening type response observed in the uniaxial tensile tests with  $\phi 6$  bar specimens has also contributed for this behavior (see annex 1). The larger load bearing capacity of panel FL-4A might be related to the fact that a higher number of cracks was occurred in this panel, and more cracks were active (in crack opening process) beyond the deflection corresponding to  $F_{sy}$ .

Figure 84 - Force-mid span deflection of series FL-A.

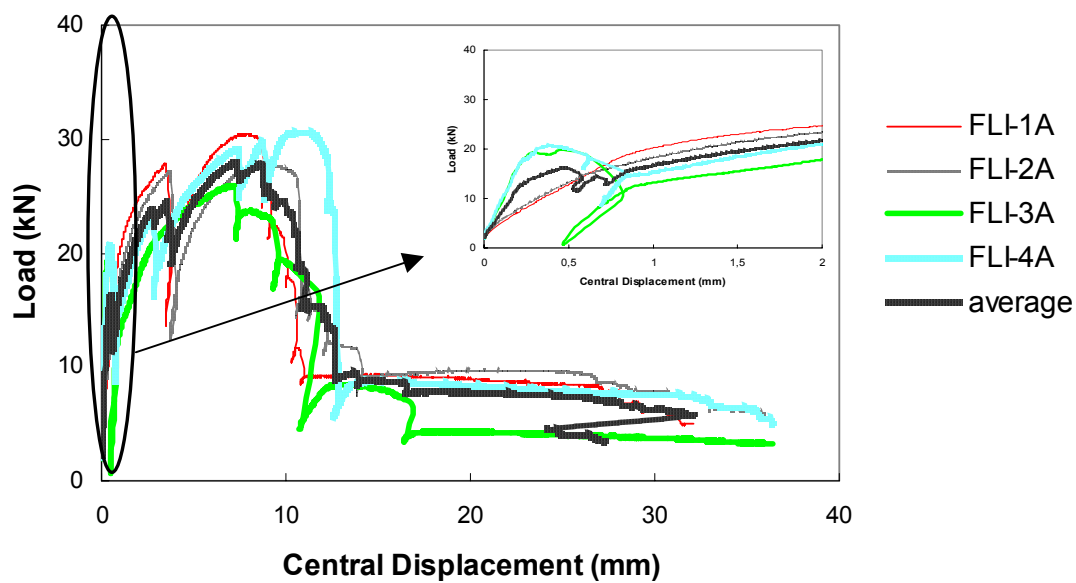
The relationship between the force and the panel mid span deflection of series FLI-A is depicted in Figure 85. In general, the behavior of the panels of this series is similar. However, up to a deflection of about 0.5 mm the stiffness of the panels FLI-1A and FLI-2A was lower than the stiffness observed in panels FLI-3A and FLI-4A, which might be related to the tensile strength of the concrete layer and to the position of the wire mesh. The wire mesh in panels FLI-3A and FLI-4A might have been at the middle surface of the concrete layer, giving a higher contribution for the tension stiffening effect. In panels FLI-1A and FLI-2A the wire mesh might have been positioned at brick-concrete layer interface.

Figure 85 - Force-mid span deflection of series FLI-A.

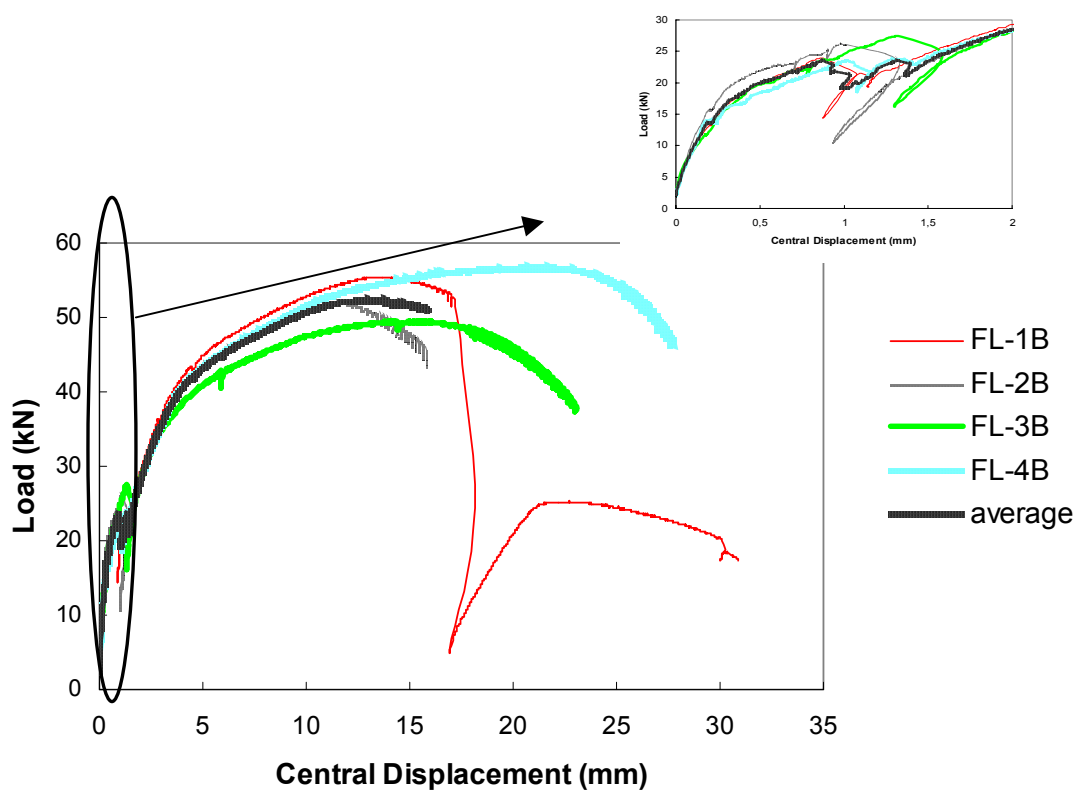
Figure 86 includes the force-mid span deflection relationship of series FL-B.

Figure 86 - Force-mid span deflection of series FLI-B.

The panels of this series had very similar deformational behavior up to a deflection of about 3 mm, when a considerable loss of stiffness occurred, due to yield initiation of the longitudinal reinforcement. After this deflection the stiffness and the load bearing capacity of panel FL-3B was less than of the remaining panels, maybe due to the larger number of cracks formed in this panel.

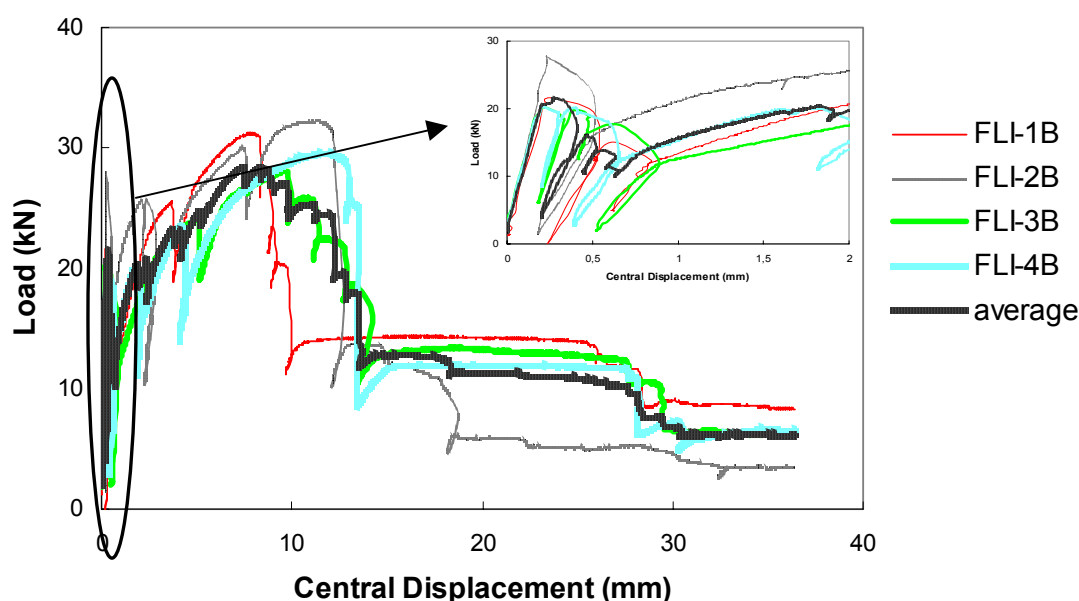
The force-mid span deflection relationship of series FLI-B is represented in Figure 87. Up to a load of about 20 kN the panels have showed a quasi-elastic response. After the deflection corresponding to this load, a decay on the load occurred due to the formation of macro-cracks. Then, the wire mesh was activated, resulting an increment in the panel load bearing capacity up to the moment when wires of the mesh have ruptured. The structural softening occurred for a mid span deflection of about 10 mm.

Figure 87 - Force-mid span deflection of series FLI-B.

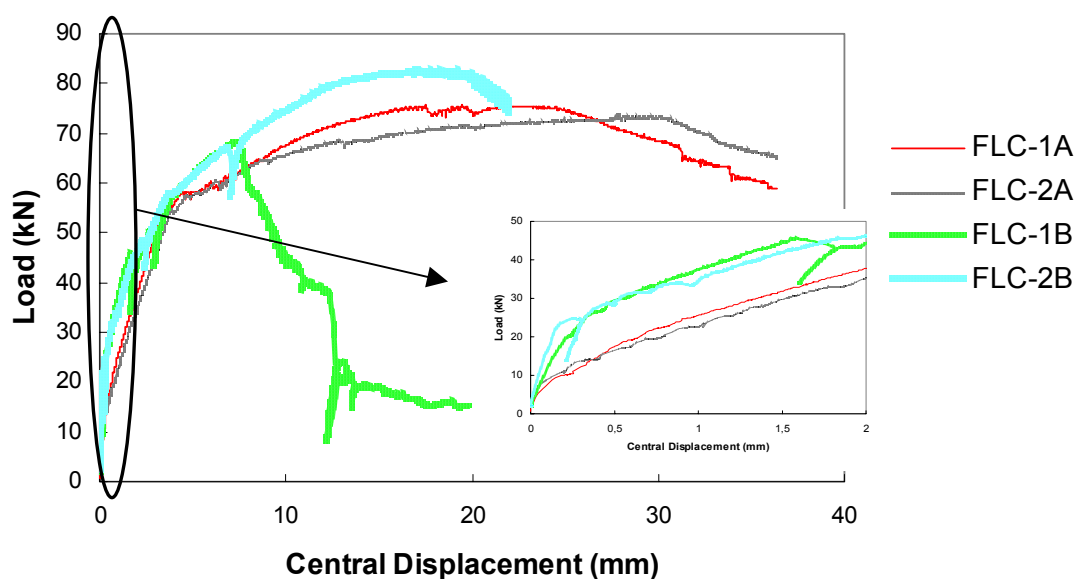
Figure 88 represents the force-mid span deflection relationship of series FLC-A and FLC-B. The only difference between these series and the corresponding FL-A and FL-B series was the distance between the line loads, which was increased in the former series in order to, eventually, induce shear failure. The shear span of series FLC was about  $175/75 \approx 2.3$ . In concrete elements with this shear span value and without shear reinforcement, shear failure would be expected. However, only panel FLC-1B failed by

shear, resulting in a brittle failure mode and inferior load bearing capacity. The remaining panels failed by bending, showing a very ductile behavior. As panels of series FLC-B had three longitudinal concrete ribs while series FLC-A had only two, the stiffness of series FLC-B was larger. Series FLC- had larger load bearing capacity than series FL-.

Figure 88 - Force-mid span deflection of series FLC.

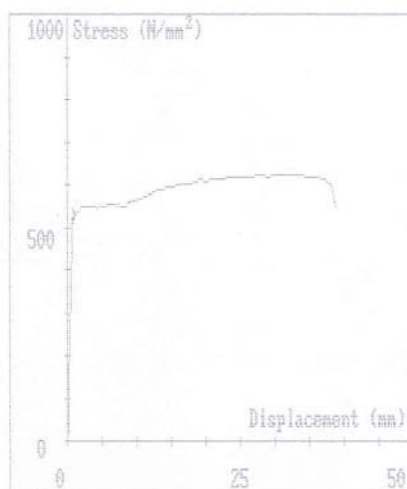
Eng Civil				EN 10 002-1 : 1990			
FILE DATA							
File name		CIVIL00		Test number		11	
File ID.		LEM		Date		20/01/03	
Config. File		ENG MEC		Time		12:48	
SPECIMEN DATA							
Specimen code		A1-8		ENGa			
Diameter		8.000 mm		MEC  NICA			
				x			
Area		50.30 mm <sup>2</sup>		x			
Parallel length		280.0 mm		x			
Initial G.L		280.0 mm					
Final G.L		318.2 mm					
TEST RESULTS							
Fm		31.4 kN		OK			
Rm		625 N/mm <sup>2</sup>		OK			
Rp .1%		514 N/mm <sup>2</sup>		OK			
Rp .2%		537 N/mm <sup>2</sup>		OK			
				At		14.0 % OK	
Test complete :- Fracture detected Araújo

Figure 89 – Test of bar diameter 8mm.

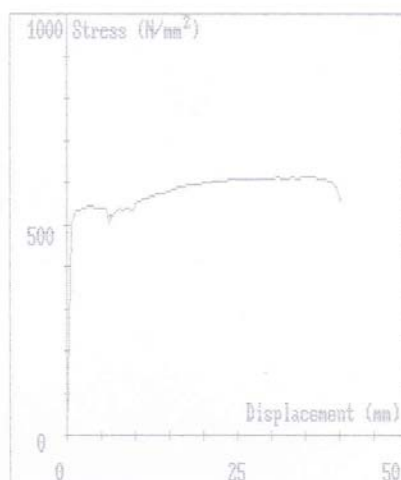
Eng Civil				EN 10 002-1 : 1990			
FILE DATA							
File name		CIVIL00		Test number		12	
File ID.		LEM		Date		20/01/03	
Config. File		ENG MEC		Time		12:55	
SPECIMEN DATA							
Specimen code		A2-8		ENGA			
Diameter		8.000 mm		MEC  NICA			
Area		50.30 mm²		x			
Parallel length		280.0 mm		x			
Initial G.L		280.0 mm		x			
Final G.L		319.5 mm					
TEST RESULTS							
Fm		30.9 kN		OK			
Rm		613 N/mm²		OK			
Rp .1%		518 N/mm²		OK		At 14.5 % OK	
Rp .2%		526 N/mm²		OK			
Test complete :- Fracture detected Araújo

Figure 90 - Test of bar diameter 8mm.

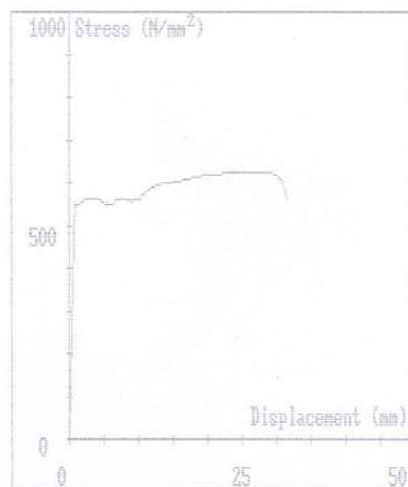
Eng Civil				EN 10 002-1 : 1990			
FILE DATA							
File name		CIVIL00		Test number		14	
File ID.		LEM		Date		20/01/03	
Config. File		ENG MEC		Time		13:02	
SPECIMEN DATA							
Specimen code		A3-8		ENGA			
Diameter		8.000 mm		MEC  NICA			
				x			
Area		50.30 mm <sup>2</sup>		x			
Parallel length		280.0 mm		x			
Initial G.L		280.0 mm					
Final G.L		310.8 mm					
TEST RESULTS							
Fm		31.5 kN		OK			
Rm		627 N/mm <sup>2</sup>		OK			
Rp .1%		553 N/mm <sup>2</sup>		OK		At 11.5 % OK	
Rp .2%		548 N/mm <sup>2</sup>		OK			
Test complete :- Fracture detected Araújo

Figure 91 - Test of bar diameter 8mm.

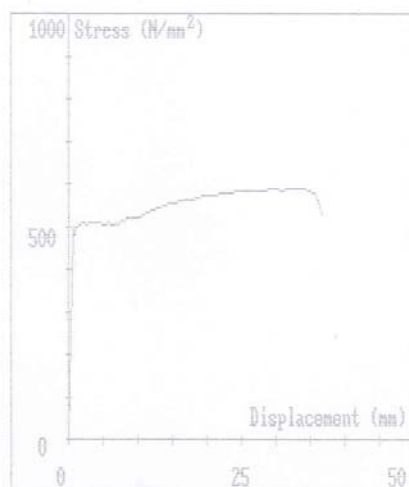
Eng Civil				EN 10 002-1 : 1990			
FILE DATA							
File name		CIVIL00		Test number		15	
File ID.		LEM		Date		20/01/03	
Config. File		ENG MEC		Time		13:07	
SPECIMEN DATA							
Specimen code		A4-8		ENGa			
Diameter		8.000 mm		MEC  NICA			
				x			
Area		50.30 mm <sup>2</sup>		x			
Parallel length		280.0 mm		x			
Initial G.L		280.0 mm					
Final G.L		315.9 mm					
TEST RESULTS							
Fm		29.6 kN		OK			
Rm		589 N/mm <sup>2</sup>		OK			
Rp .1%		483 N/mm <sup>2</sup>		OK			
Rp .2%		486 N/mm <sup>2</sup>		OK			
				At		13.0 % OK	
Test complete :- Fracture detected Araújo

Figure 92 - Test of bar diameter 8mm.

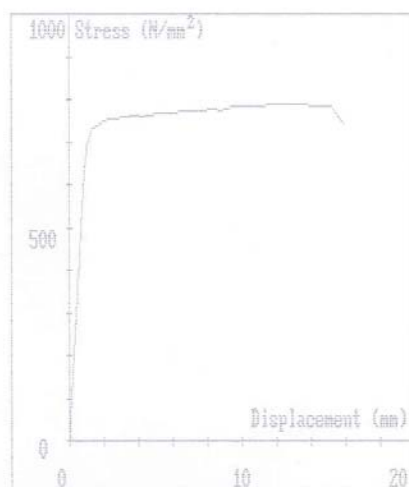
Eng Civil				EN 10 002-1 : 1990			
FILE DATA							
File name		CIVIL00		Test number		7	
File ID.		LEM		Date		20/01/03	
Config. File		ENG MEC		Time		12:13	
SPECIMEN DATA							
Specimen code		A1-6		ENGA			
Diameter		6.000 mm		MEC  NICA			
Area		28.30 mm <sup>2</sup>		x			
Parallel length		280.0 mm		x			
Initial G.L		280.0 mm		x			
Final G.L		294.9 mm					
TEST RESULTS							
Fm		22.4 kN		OK			
Rm		791 N/mm <sup>2</sup>		OK			
Rp .1%		731 N/mm <sup>2</sup>		OK		At 5.5 % OK	
Rp .2%		739 N/mm <sup>2</sup>		OK			
Test complete :- Fracture detected Araújo

Figure 93 - Test of bar diameter 6mm.

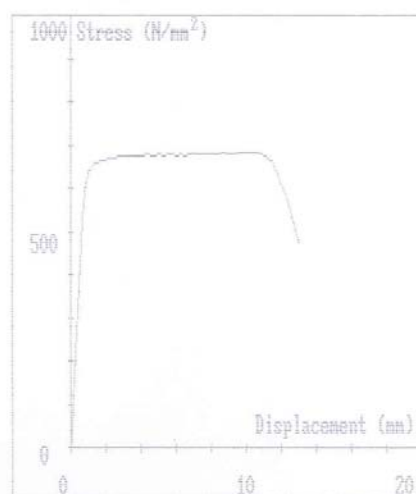
Eng Civil				EN 10 002-1 : 1990			
FILE DATA							
File name		CIVIL00		Test number		8	
File ID.		LEM		Date		20/01/03	
Config. File		ENG MEC		Time		12:33	
SPECIMEN DATA							
Specimen code		A2-6		ENGa			
Diameter		6.000 mm		MEC  NICA			
				x			
Area		28.30 mm <sup>2</sup>		x			
Parallel length		280.0 mm		x			
Initial G.L		280.0 mm					
Final G.L		292.4 mm					
TEST RESULTS							
Fm		19.4 kN		OK			
Rm		685 N/mm <sup>2</sup>		OK			
Rp .1%		647 N/mm <sup>2</sup>		OK			
Rp .2%		660 N/mm <sup>2</sup>		OK			
				At		4.5 % OK	
Test complete :- Fracture detected							
Araújo

Figure 94 - Test of bar diameter 6mm.

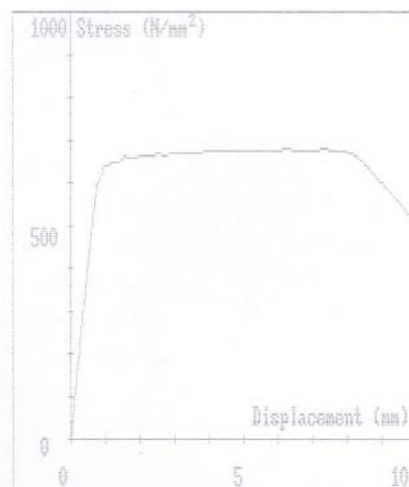
Eng Civil				EN 10 002-1 : 1990			
FILE DATA							
File name		CIVIL00		Test number		9	
File ID.		LEM		Date		20/01/03	
Config. File		ENG MEC		Time		12:37	
SPECIMEN DATA							
Specimen code		A3-6		ENGA			
Diameter		6.000 mm		MEC  NICA			
				x			
Area		28.30 mm <sup>2</sup>		x			
Parallel length		280.0 mm		x			
Initial G.L		280.0 mm					
Final G.L		289.1 mm					
TEST RESULTS							
Fm	19.2	kN	OK				
Rm	678	N/mm <sup>2</sup>	OK				
Rp .1%	641	N/mm <sup>2</sup>	OK	At	3.5	%	OK
Rp .2%	651	N/mm <sup>2</sup>	OK				
Test complete :- Fracture detected							
Araújo

Figure 95 - Test of bar diameter 6mm.

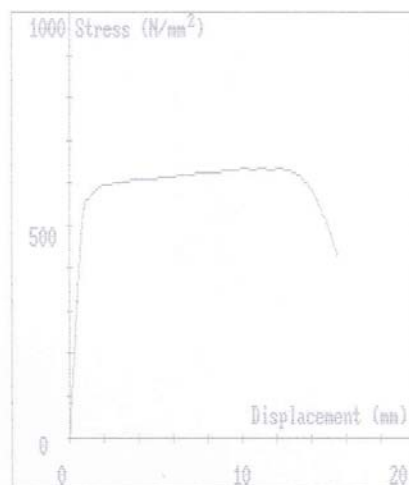
Eng Civil				EN 10 002-1 : 1990			
FILE DATA							
File name		CIVIL00		Test number		10	
File ID.		LEM		Date		20/01/03	
Config. File		ENG MEC		Time		12:42	
SPECIMEN DATA							
Specimen code		A4-6		ENGa			
Diameter		6.000 mm		MEC  NICA			
				x			
Area		28.30 mm <sup>2</sup>		x			
Parallel length		280.0 mm		x			
Initial G.L		280.0 mm					
Final G.L		294.9 mm					
TEST RESULTS							
Fm		17.9 kN		OK			
Rm		634 N/mm <sup>2</sup>		OK			
				At		5.5 % OK	
Test complete :- Fracture detected Araújo

Figure 96 - Test of bar diameter 6mm.

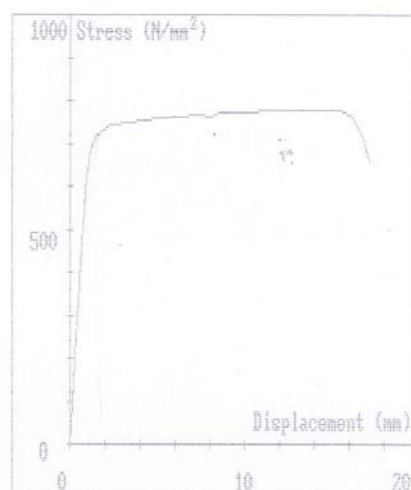
Eng Civil		DIN 50 145 : 1975	
FILE DATA			
File name	CIVIL00	Test number	16
File ID.	LEM	Date	21/01/03
Config. File	ENG MEC	Time	11:49
SPECIMEN DATA			
Specimen code	A5-6	ENGa	
Diameter	6.000 mm	MEC  NICA	
Area	28.30 mm <sup>2</sup>	x	
Parallel length	280.0 mm	x	
Initial G.L	280.0 mm	x	
Final G.L	296.3 mm		
TEST RESULTS			
Fm	22.1 kN	OK	
Rm	781 N/mm <sup>2</sup>	OK	
Rp .1%	681 N/mm <sup>2</sup>	OK	At 6.0 % OK
Rp .2%	717 N/mm <sup>2</sup>	OK	
<p><i>para <math>\epsilon_0 = 5 \times d - At = 10,3\%</math></i></p>			
Test complete :- Fracture detected			
Araújo

Figure 97 - Test of bar diameter 6mm.

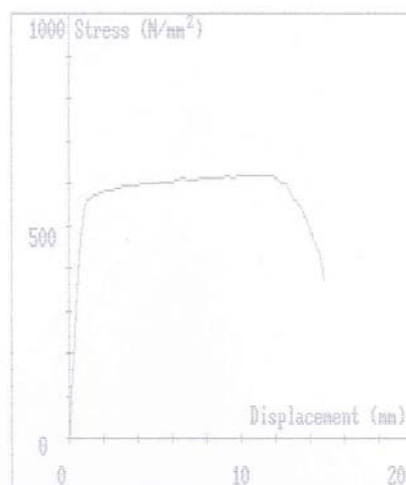
Eng Civil				DIN 50 145 : 1975			
FILE DATA							
File name		CIVIL00		Test number		17	
File ID.		LEM		Date		21/01/03	
Config. File		ENG MEC		Time		11:58	
SPECIMEN DATA							
Specimen code		A6-6		ENGA			
Diameter		6.000 mm		MEC  NICA			
Area		28.30 mm <sup>2</sup>		x			
Parallel length		280.0 mm		x			
Initial G.L		280.0 mm		x			
Final G.L		294.3 mm					
TEST RESULTS							
Rm		620		N/mm <sup>2</sup>		OK	
Rp .1%		562		N/mm <sup>2</sup>		OK	
Rp .2%		573		N/mm <sup>2</sup>		OK	
Partiu fora dos limites de REFERENCIA.							
Test complete :- Fracture detected							
Araújo

Figure 98 - Test of bar diameter 6mm.

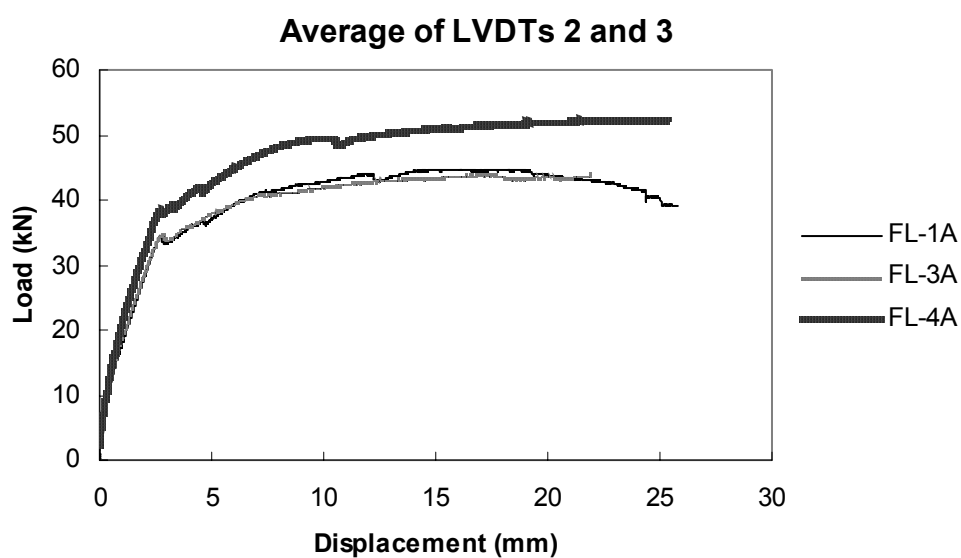
Figure 99 - Curves of displacements (average LVDT 2 and 3)  $\times$  load – series FL-A.

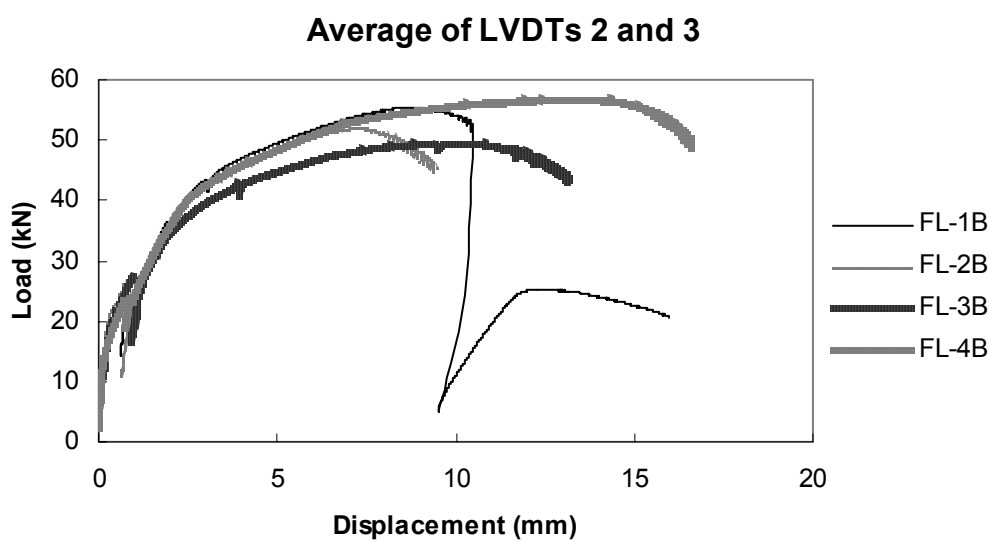
Figure 100 - Curves of displacements (average LVDT 2 and 3)  $\times$  load – series FL-B.

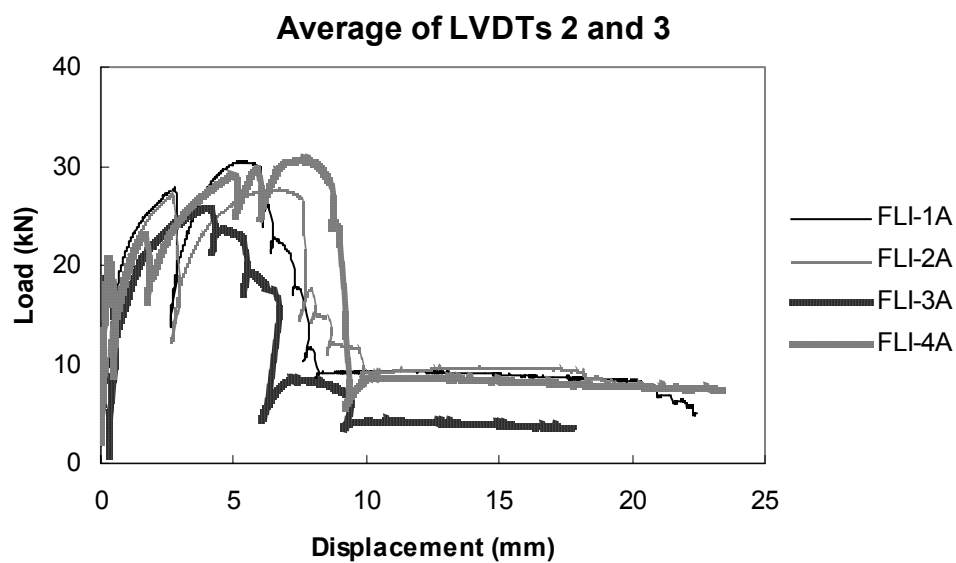
Figure 101 - Curves of displacements (average LVDT 2 and 3)  $\times$  load – series FLI-A.

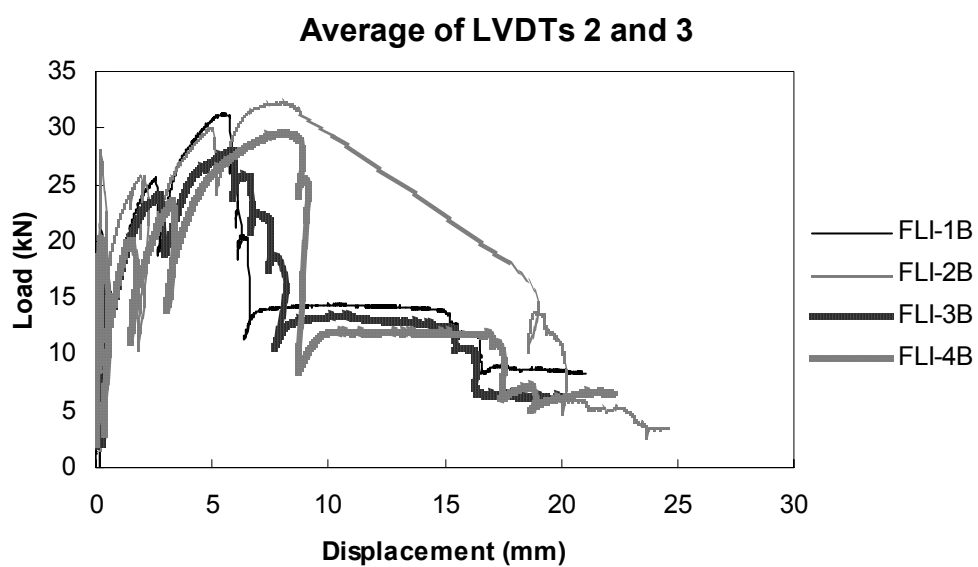
Figure 102 - Curves of displacements (average LVDT 2 and 3)  $\times$  load – series FLI-B.

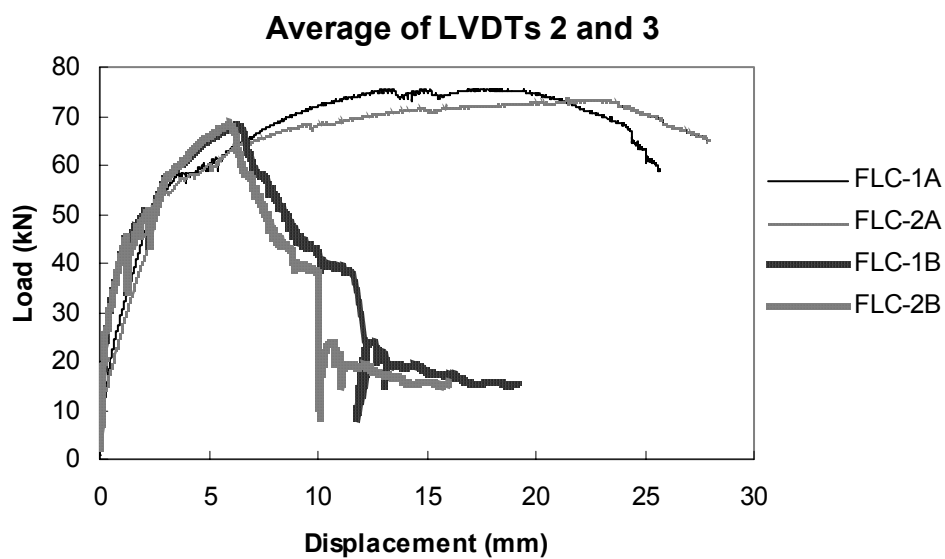
Figure 103 - Curves of displacements (average LVDT 2 and 3)  $\times$  load – series FLC.

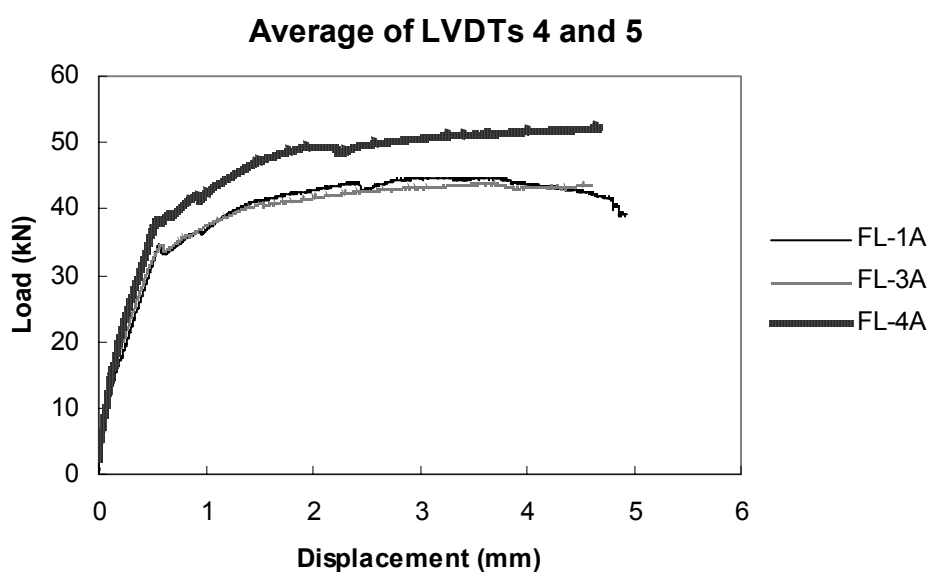
Figure 104 - Curves of displacements (average LVDT 4 and 5)  $\times$  load – series FL-A.

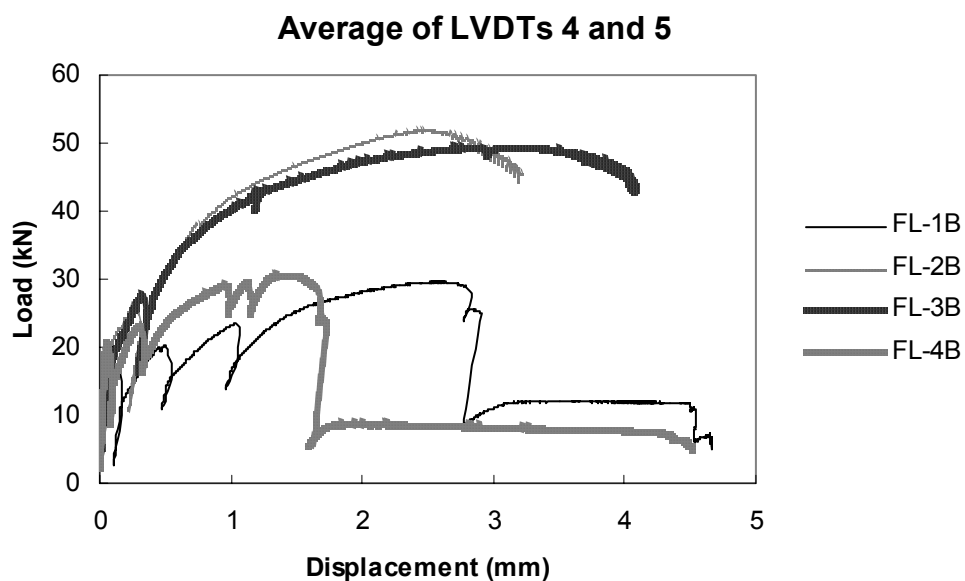
Figure 105 - Curves of displacements (average LVDT 4 and 5)  $\times$  load – series FL-B.

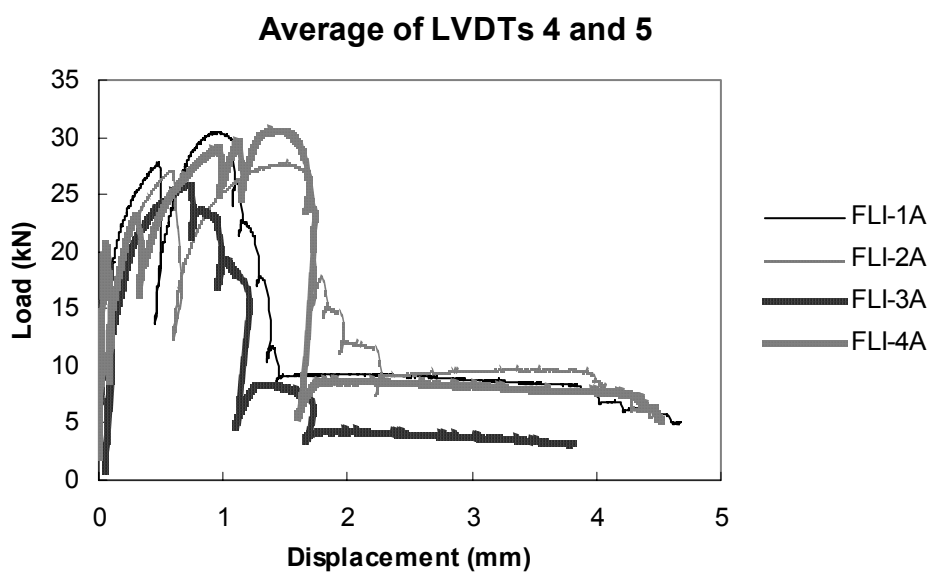
Figure 106 - Curves of displacements (average LVDT 4 and 5)  $\times$  load – series FLI-A.

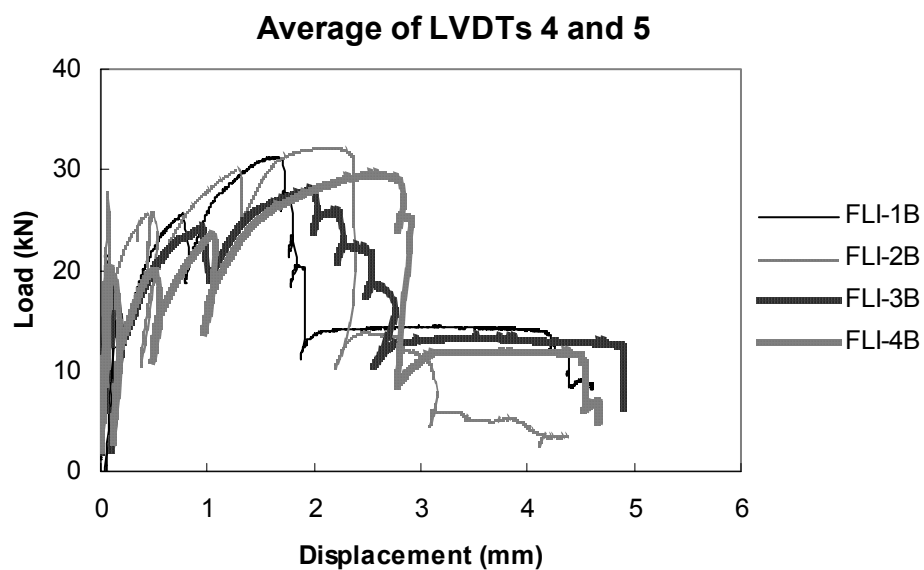
Figure 107 - Curves of displacements (average LVDT 4 and 5)  $\times$  load – series FLI-B.

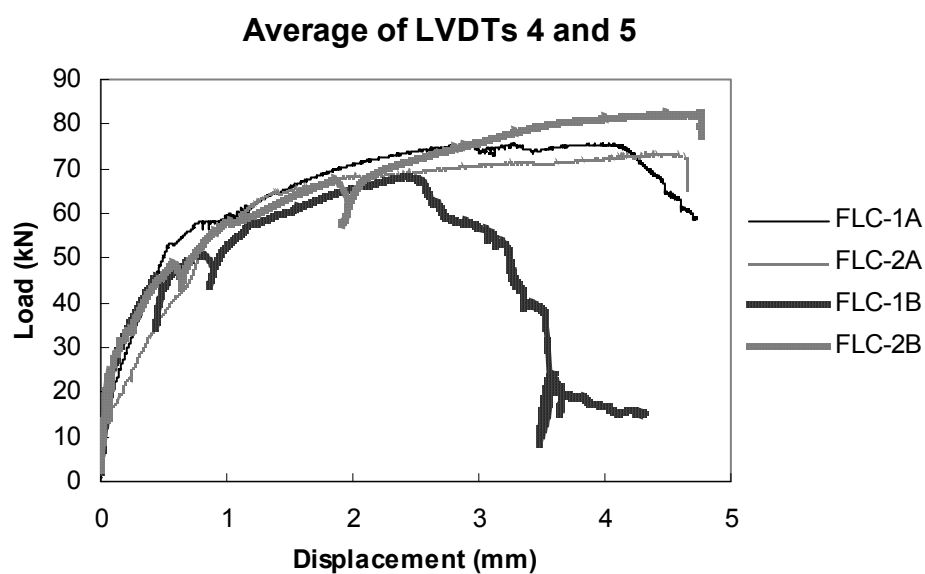
Figure 108 - Curves of displacements (average LVDT 4 and 5)  $\times$  load – series FLC.
